TEST PERFORMED ON ECI COMPOSITE BUSHINGS

Purpose of this paper

The purpose of this paper is to explain the series of tests performed on the bushings designed and manufactured by ELECTRO COMPOSITES INC. These series of tests have been done to build the appropriate engineering database, which is used on a daily basis, to design and manufacture bushings for electrical applications; voltage range up to 46 kV and current range up to 3000 amps.

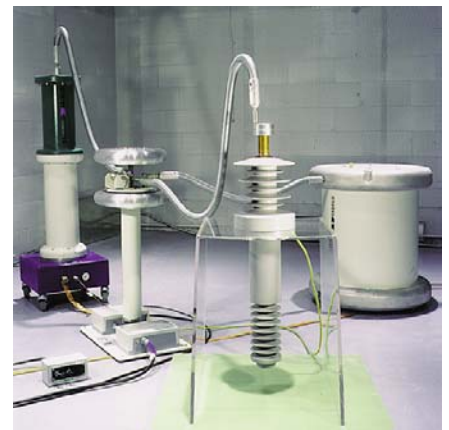
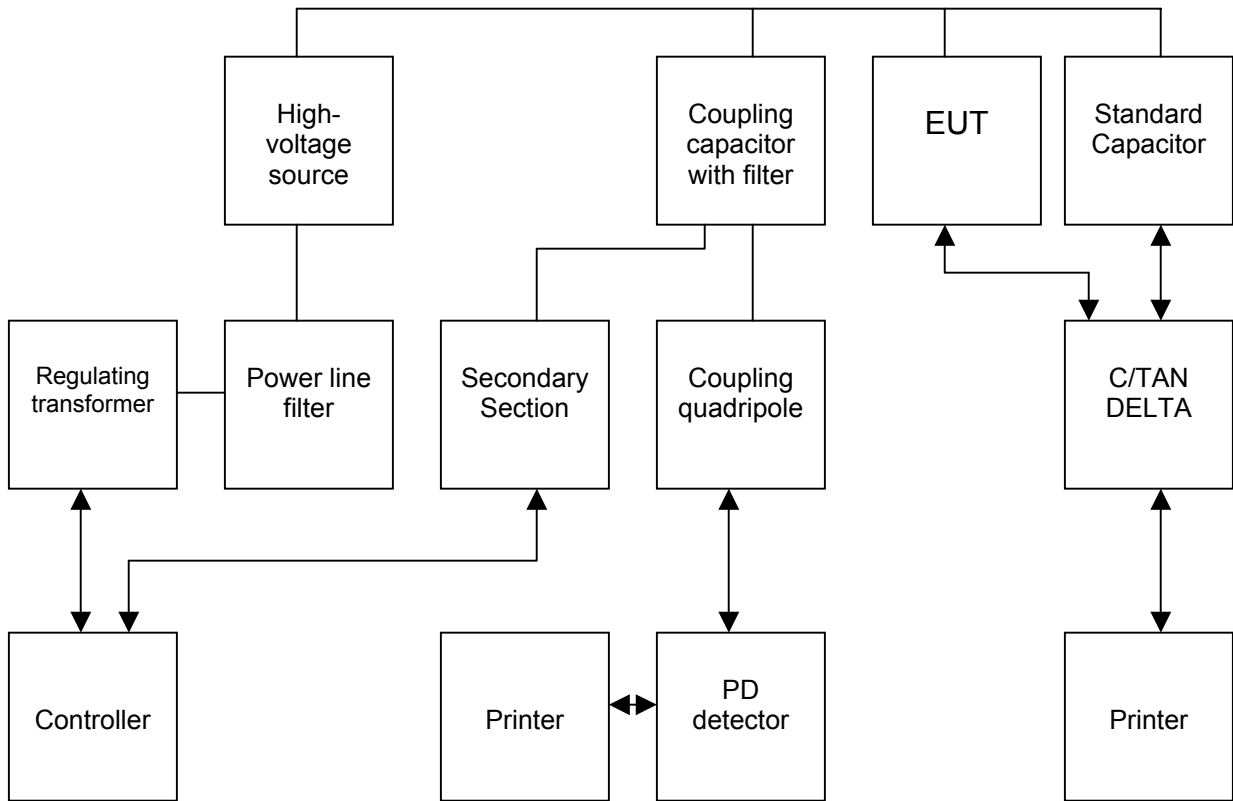
Figure 1

Test setup to measure partial discharge, capacitor value and power factor.

State of the art instrumentation was used to perform these tests. A Farady cage was used to reduce the noise level to a minimum.

- Measurement of partial discharge is one of the key measurement done to detect voids in the material. This test was performed at; a) $1.05 \times \text{rated voltage}/\sqrt{3}$, b) $1.5 \times \text{rated voltage}/\sqrt{3}$. The measurement should be respectively less than 5 Pico Coulomb for (a) and less than 10 Pico Coulomb for (b). Up to now, due to the design and process used for EC bushings, giving no significant porosity, the measurement of partial discharge was very low. The typical value is below 2 Pico Coulomb. This measurement was made on each bushing and is part of the EC standard test report. The measurement of capacitive value and power factor are also done. **This is part of the EC standard report on each bushing we produce.**
